# Common Construction

# Defects

**by Pete Fowler**

A guided tour through some of the most common errors and omissions fueling the litigation frenzy in the California building industry

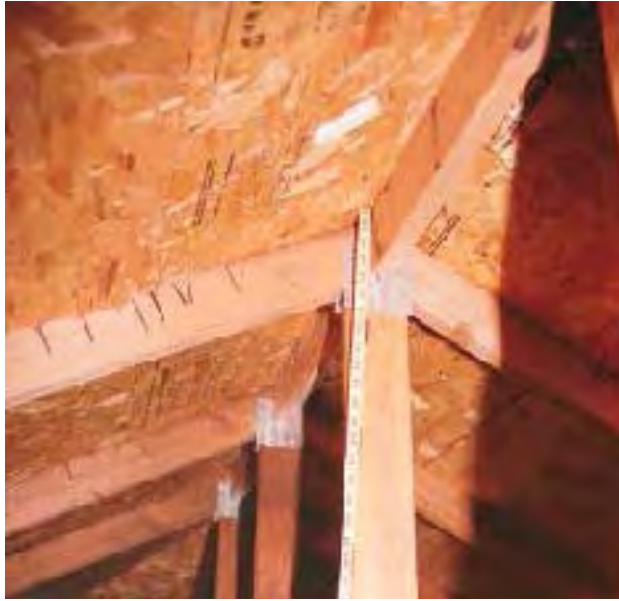
**Figure 1.** Nails that miss the truss — a result of sloppy work with a pneumatic nailer — void the strength of the roof diaphragm.

Failure to follow the nailing requirements for shear walls and diaphragms is a common defect. Many builders temporarily set the plywood in place with a few hand-driven nails, then return later to finish the nailing with a gun. Unfortunately, we sometimes find that the second step in the process has been forgotten and the finish materials are installed over inadequately attached plywood. Another typical mistake is the substitution of box nails or sinkers for the specified common nails, or use of a smaller size nail. Figure 1 shows an example of just plain sloppy nailing.

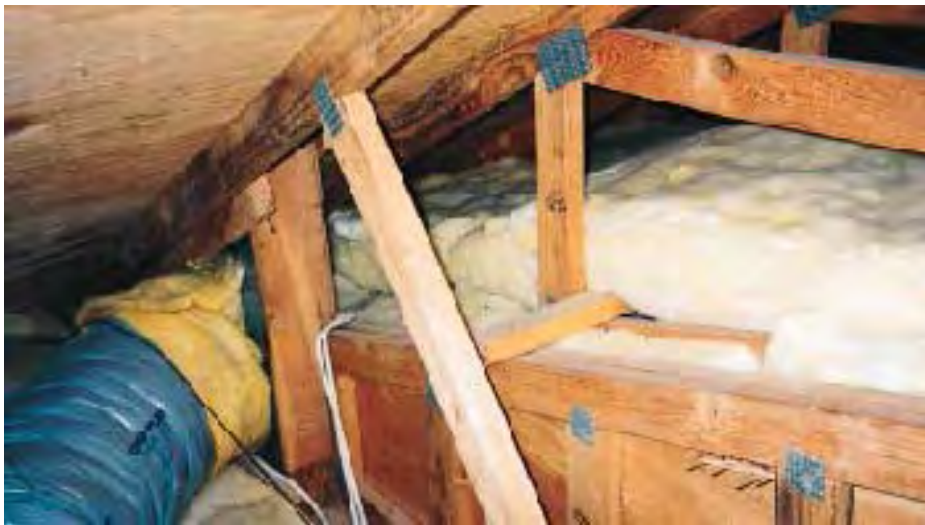
**Figure 2.** The plywood on this interior shear wall should have been carried all the way to the roof diaphragm.

A more subtle but common problem is failure to carry an interior shear wall all the way to the roof diaphragm (Figure 2). This vertical continuity is necessary for the shear wall to transfer lateral forces from the roof diaphragm down to the foundation.

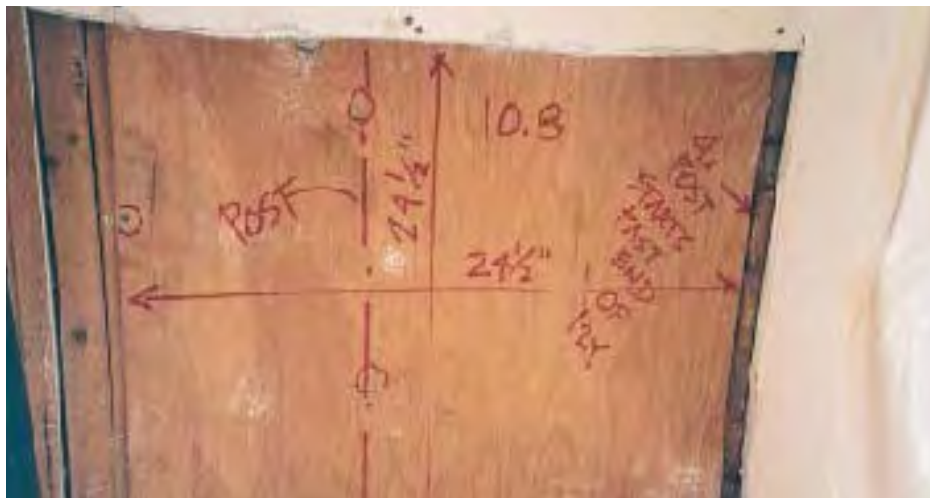
**Figure 3.** This shear plywood falls short of the shear wall posts on the right and left, and is attached with too few nails.

Sometimes the shear plywood does not extend across the entire width of the shear wall area and thus doesn't reach the post and hold-down that make the system complete (Figure 3). Other times the plywood reaches only the bottom of the two top plates (Figure 4), interrupting vertical continuity at the critical connection between the top of the shear wall and the floor or roof diaphragm above. This can happen when the plywood is installed while walls are framed on the deck and the double top plate is not yet in place. A simple fix is to install a Simpson A35F (flat) or similar metal connector, but the process is made more difficult because finishes must be removed or the work must be performed in a tight attic space.

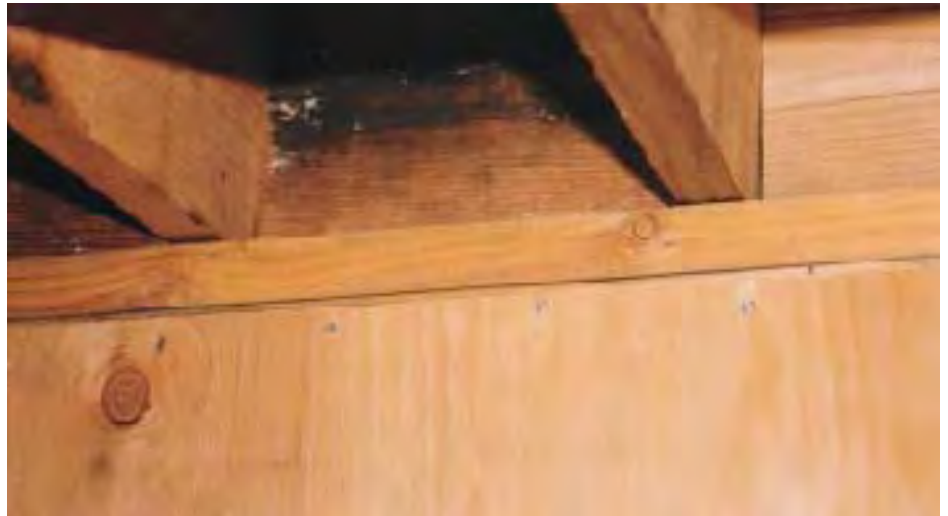
**Figure 4.** This shear plywood should have extended to the top of the double top plate — a mistake that can be remedied with the addition of metal connectors across the two plates.

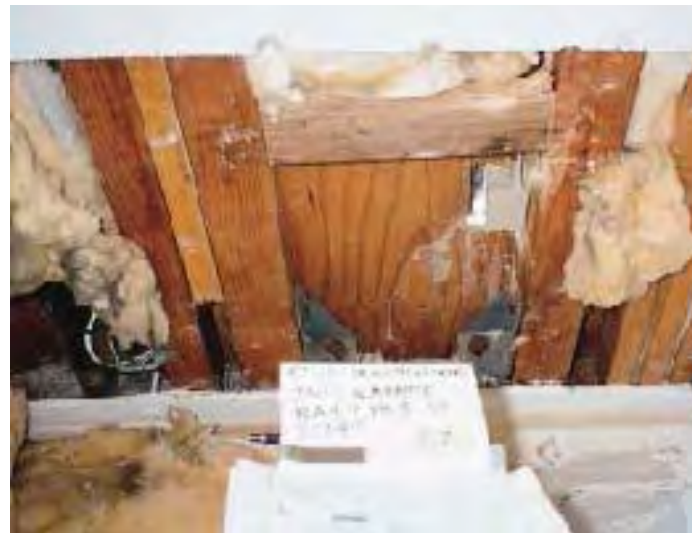
**Figure 5.** These shear wall hold-downs are too close together, making the shear wall practically useless in resisting overturning forces.

Another common mistake occurs when the hold-downs are attached to the wrong members, creating a shorter shear wall than the plans called for. This is important because the uplift load on the hold-downs increases exponentially as the hold-downs get closer together. When hold-downs are placed too close together, the uplift loads will exceed the hold-down's capacity, creating the potential for catastrophic failure in an earthquake or hurricane (Figure 5).

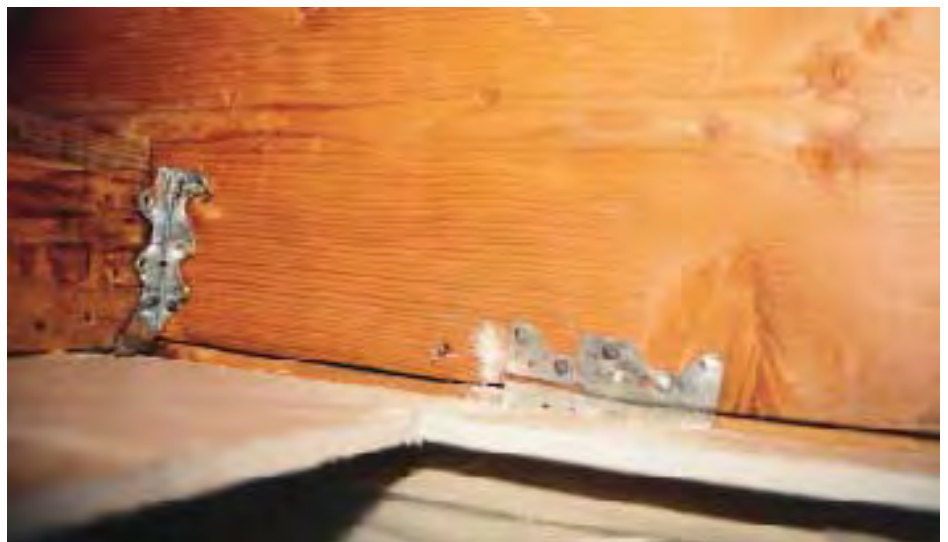
**Figure 6.** An inspection made through a hole cut in the ceiling reveals that the joist hanger at left is bent and missing nails.

Improper installation of joist and beam hangers is also quite common (Figure 6). These metal connectors frequently have missing nails and are often found mangled and twisted out of shape, having been cut or bent to fit an application never intended by the manufacturer or structural designer.

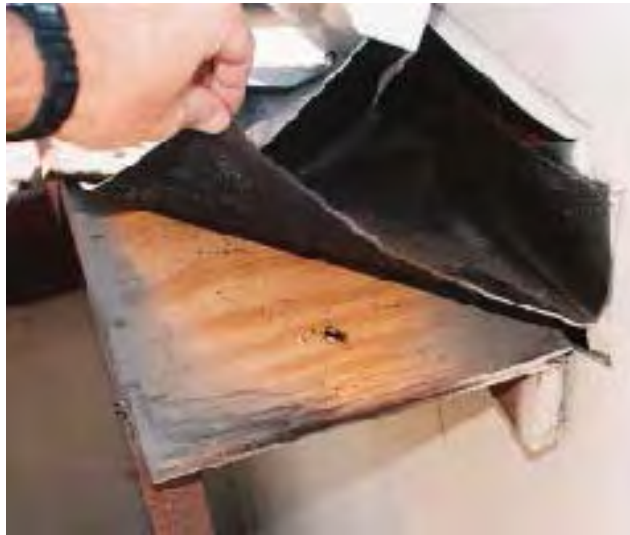
**Figure 7.** Instead of folding down over the edge, the felt paper on this rake overhang was cut flush with the top of the sheathing, allowing rain water to wet the surface of the roof deck.

One of the most common mistakes I see is the failure of the roofer to turn down the 30-lb. felt underlayment to cover the edge of the decking at the rake. Instead, the felt is cut flush with the top edge of the roof sheathing or barge rafter. Any water that makes its way past the rake tiles has an easy path onto the wood deck (Figure 7). Unfortunately, like most roofing defects, this cannot be readily inspected on a completed roof because the rake tiles cover the edge of the roof.

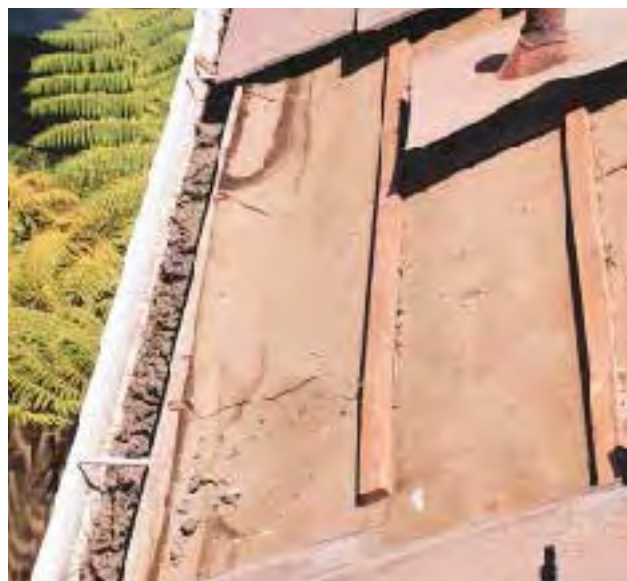
**Figure 8.** A raised fascia board (illustration) requires a heavy metal flashing or cant strip to ensure that runoff passes over the edge. Otherwise, water will pond, as in the photo, resulting in leaks and rot in the eaves.

Another common mistake involves a standard tile roof detail: the raised fascia board. The detail is acceptable, but accommodation must be made for the void that is created behind the fascia board by installing a sheet metal flashing or other anti-ponding device. Many roofing contractors omit this flashing, and the underlayment soon begins to sag and pond water, which makes its way behind the fascia and into the eaves (Figure 8).

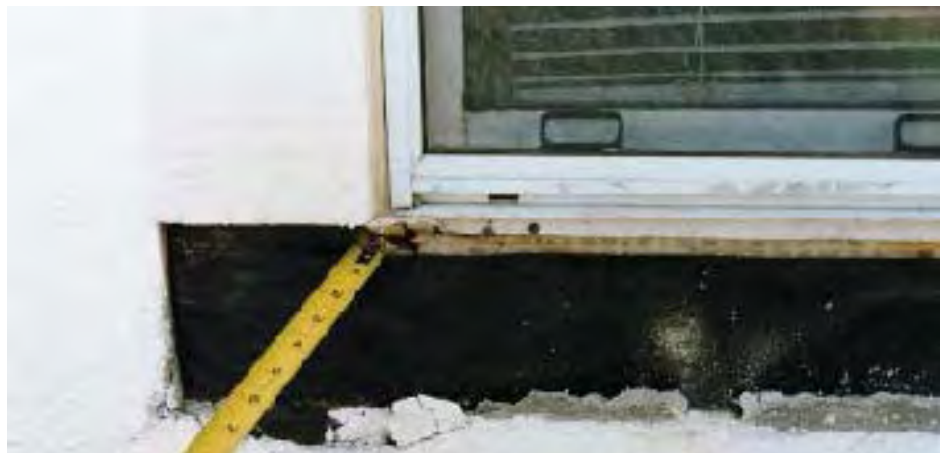
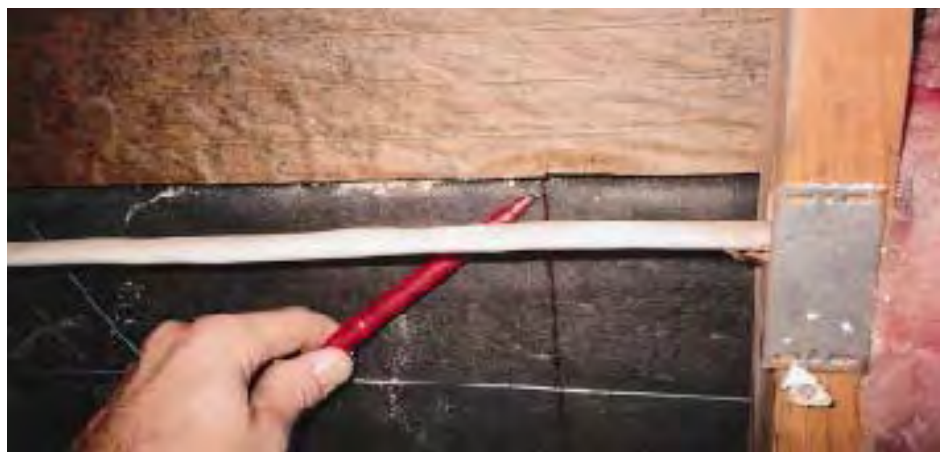
**Figure 9.** The building paper below a window must be tucked below the flashing paper — a detail often botched, as in the top photo. Above is a reverse lap seen from the inside of the wall cavity.

A classic problem is the “reverse lap” at the sill flashing paper, which should lap over the building paper below. The kraft flashing paper is put on first and the building paper is then lapped over (Figure 9). This allows water to easily enter the interior of the building envelope once it passes the exterior finish. Occasionally I’ll see an instance where a worker made an effort to get the building paper under the sill flashing paper but failed to detail the corner junction correctly (Figure 10). These mistakes can be repaired only by removing the exterior finish and reinstalling the building paper to properly integrate with the window flashing paper.

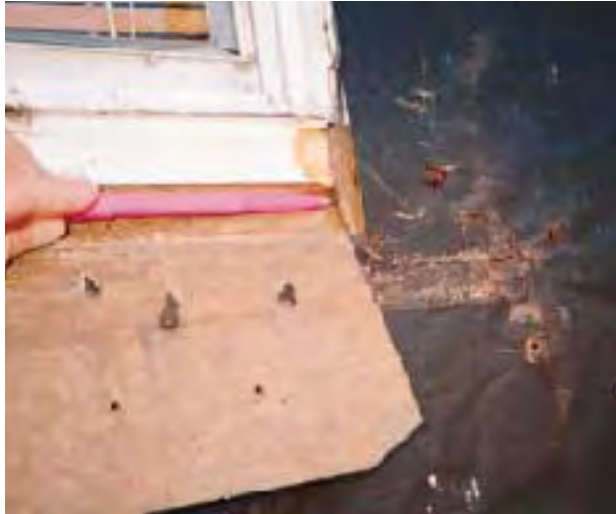
**Figure 10.** Here, the building paper is installed under the flashing paper at the bottom of the window, but not on the side — leaving a vulnerable corner where the flashing paper has been cut.

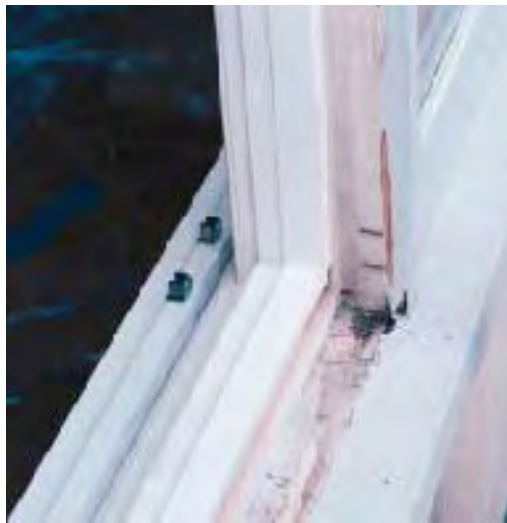
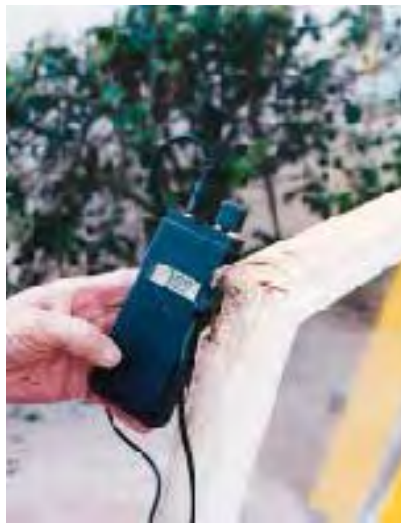
**Figure 11.** Wood windows should be painted on all raw wood surfaces. Otherwise, they will pick up excessive moisture (as the moisture meter reading in the photo at right shows), causing them to swell or even rot.

Wood windows are the exception in Southern California construction (most are aluminum), which may be the reason they are often not protected adequately from the harmful effects of moisture and temperature extremes. Although most wood windows come with an exterior primer from the factory, all components and all edges should be painted as soon as possible. When wood windows are not properly painted on all surfaces, the unfinished surfaces will take on moisture at a higher rate than the painted areas, creating uneven expansion and contraction and the possibility of rot (Figure 11). A common manifestation of damage is when the windows fail to operate properly, especially after swift changes in the weather.

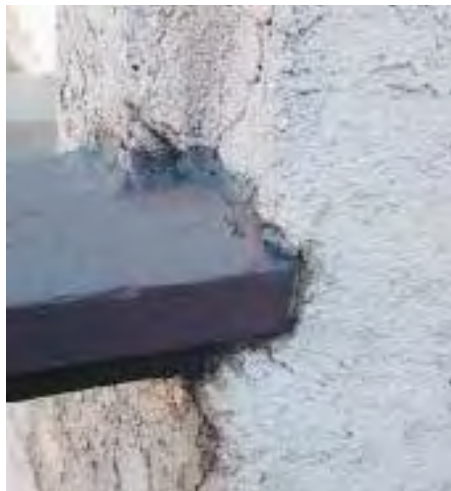
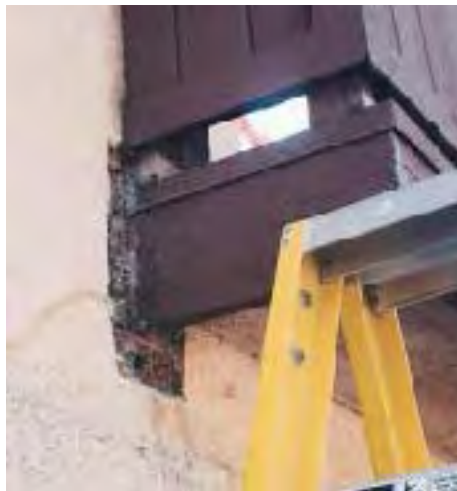
**Figure 12.** Framing protrusions, such as handrails (left) and cantilevered joists (right), are difficult to flash properly, inevitably leading to moisture intrusion, cracked stucco, and decay in the structure below.

A condition that frequently results in failure is where a deck handrail or cantilevered joist passes through the stucco skin to the framing below (Figure 12). These intersections are difficult to flash and the necessary coordination between the trades is usually lacking. The best idea is to avoid these protrusions altogether. Instead, frame the deck with four posts from the ground and stop the handrail shy of the building.

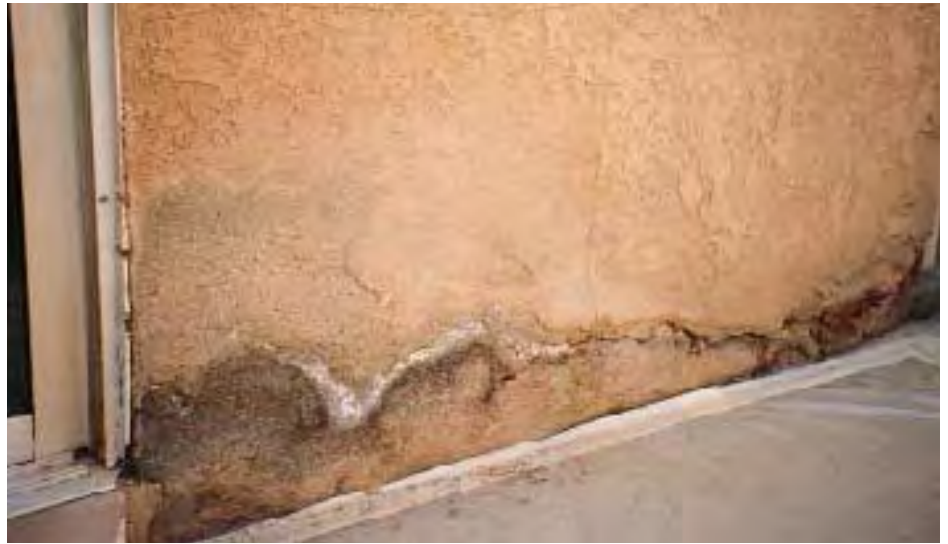
**Figure 13.** The stucco at the bottom of this wall (photo, top) should have terminated with a weep screed above grade rather than being buried behind an outdoor patio slab.

Because a traditional stucco exterior is not “waterproof,” some accommodation must be made to allow moisture to escape. The *Uniform Building Code* mandates the installation of a galvanized steel weep screed at the base of the wall (Figure 13). The screed is nailed to the sill plate, and its upper leg is covered by the building paper. This creates a neat and clean termination for the plaster in addition to allowing the escape of moisture that has found its way behind the stucco.

Unfortunately, all too often the screed is buried behind a patio slab or concrete walk that gets installed after the stucco contractor has left — again, a problem in coordination and planning. When this happens, moisture can't escape, causing the stucco to deteriorate and frequently leading to rot in the sheathing and framing.

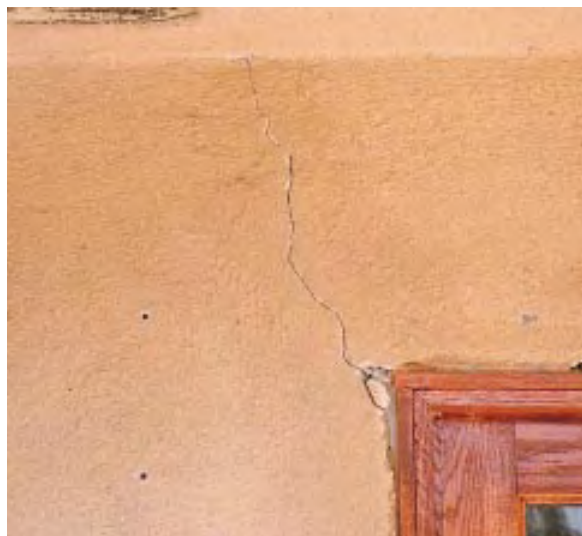
**Figure 14.** Stucco cracking is one of the most common customer complaints. Tight surface cracks are normal in stucco and can usually be repaired. With quality workmanship, larger cracks can be avoided.

Stucco cracking is one of the most common homeowner complaints (Figure 14). In part, this is a matter of

education: Homeowners should be told to expect minor surface cracks as the stucco shrinks. But it's also a matter of workmanship. Many cracks could be avoided by paying attention to control joints, proper attachment of lath, allowing enough time between coats, and moist curing.

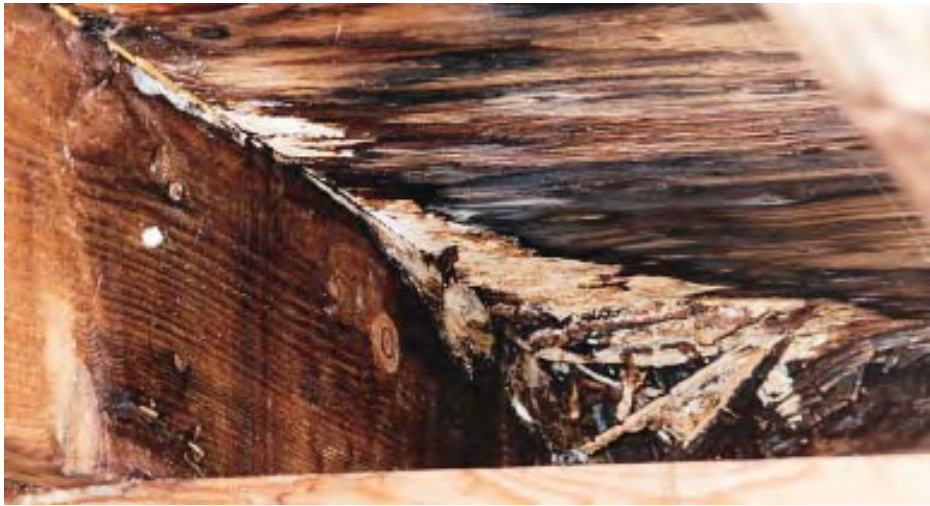
**Figure 15.** Because waterproof decks are difficult to detail properly, rotting substructure is a common defect.

The photo on shows a poorly flashed post penetration. The unsealed flashing acted more like a funnel, sending the water right into the framing and keeping it there, where it could do the kind of damage evident in Figure 15. Ponding of water on waterproof decks is another common problem (Figure 16), which can also lead to rot in the structure below.

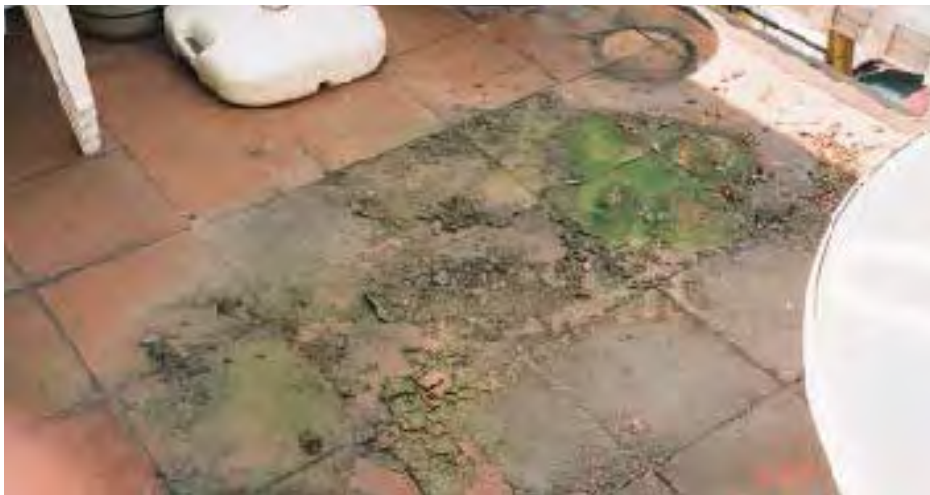
**Figure 16.** Besides ruining the finish surface, ponding on waterproof decks also leads to deterioration of the framing below.

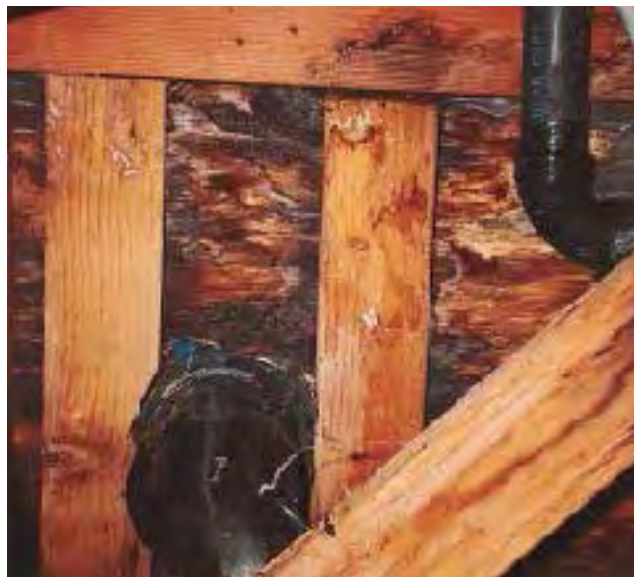
**Figure 17.** If hidden by finish surfaces, a leaky toilet connection can go undetected until structural decay sets in.

A common source for a plumbing leak is a poorly installed toilet (Figure 17). The connection to the closet flange is important because the toilet receives so much use, which includes supporting the entire body weight of the user. If the toilet has not been set level, or if the flange is too high or low in relation to the finish floor, it's only a matter of time before a leak develops. A leaky toilet often goes unnoticed for some time, since the water may leak under the finish flooring directly into the framing.

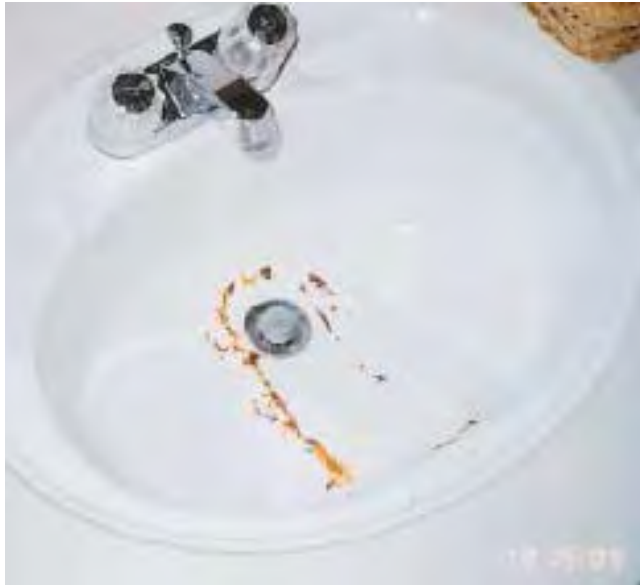
**Figure 18.** The chipped enamel in this cheap lavatory sink is the kind of defect that will send condo or tract homeowners ballistic — especially when they see it in every home on the block.

This is a manufacturing defect plain and simple — and one that tends to be highly visible and irritating to owners (Figure 18). Although it's not a structural concern, if condo owners or tract house dwellers notice this in one another's homes, it can help start the defect litigation ball rolling. The chipping is normally located at the spot welds in the sinks. The enamel doesn't stick well to the welds and easily chips away, sometimes in a pattern. The solution is not to buy cheap sinks from manufacturers you have not heard of.

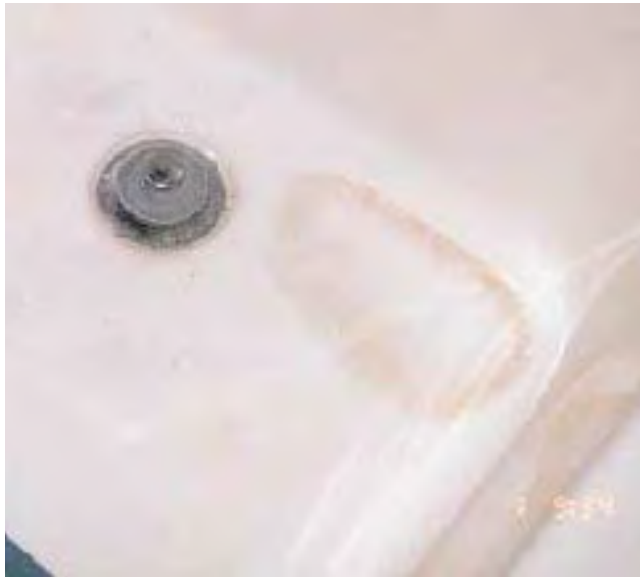
**Figure 19.** Ponding in the bottom of a tub unit — the result of an out-of-level installation — is not structurally serious but is obvious to any homeowner.

Ponding in a tub may be a manufacturing problem but more often stems from improper installation (Figure 19). The builder needs to take the time to check the framing, and shim and level the tub as necessary. Otherwise, water will collect and may stain the unit. Again, this is not a life or death issue, but it's one that homeowners will easily see. The cure for this defect, some might argue, is more painful than the disease:

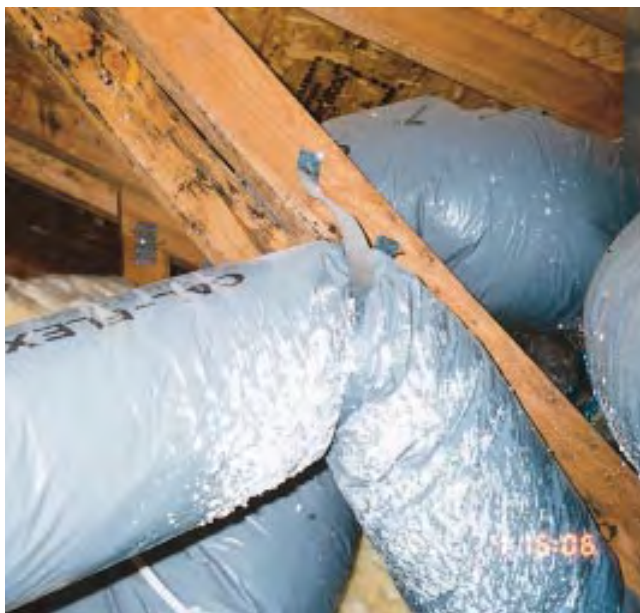
**Figure 20.** A pinched duct can result in uneven temperatures. It's easy to fix if it's accessible, but easier still to avoid.

As with plumbing, many of the hvac defects cited in a typical defect case are nuisance and code issues that are easy to correct, like construction debris in the return air plenum, unsecured units, and no trap vent on the condensate drain. These issues rarely cause serious owner dissatisfaction. Pinched or crushed ducts are another common problem (Figure 20), which can cause uneven heating or cooling and result in owner discomfort. The cause may be sloppy installation or damage by a subsequent trade. The repair is as simple as unpinching the duct or replacing any short sections that have been permanently damaged.

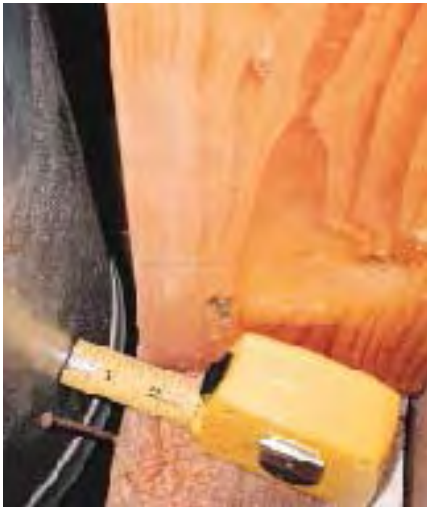
**Figure 21.** As a matter of life safety, combustion appliance vent pipes must have proper clearance to combustibles. The guidelines are usually stamped right on the appliance itself.

This is a real life safety issue that can cause fires (Figure 21, page 66). It's something the municipal inspector should catch, but it often seems to be missed. Different types of flue vents have different distance requirements from combustibles. Generally, a single-wall vent must maintain 6 to 18 inches or more clearance, while a double-wall (B, BW, or L type) needs anywhere from 1 to 9 inches, depending on the rating of the appliance it is venting. Many vents have clearance guidelines printed directly on the pipe. The stick in the spokes for builders is that many materials we normally think of as not being combustible are considered so by the fire safety section of the code. For example, drywall is considered a combustible material by this code definition.

Sometimes the repair for a problem with distance to combustibles is a simple matter of exchanging a single-wall vent with a double-wall, thus decreasing the required distance. Sometimes it might require reframing the area. The best way to avoid problems such as these is to remember that all flue pipes carrying products of combustion require some separation from com-

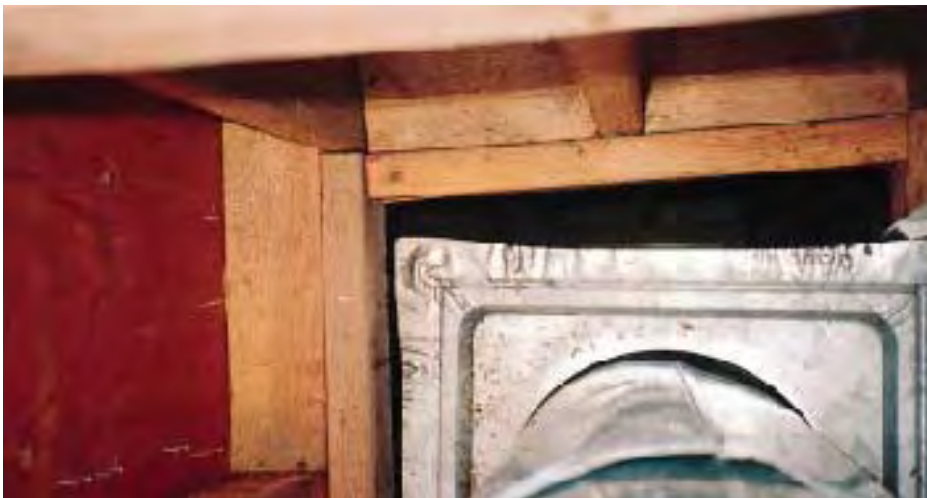
**Figure 22.** Firestops are an important safety requirement. Unfortunately, if a gap is missed by the inspector, all too often it will be permanently concealed from view.

With a mechanical firebox, a firestop must be installed at each ceiling level where the flue passes on its way to the roof. Firestops work the same way fire-blocking does to prevent fire from traveling from floor to floor, as in balloon framing. Specialty subcontractors often install fireboxes and firestops, and sometimes the installation goes into an opening that was not properly framed. Instead of calling for the framer to reframe the opening, which would cost the fireplace installer and the framer time and money, the sub often completes the installation anyway, thinking that unless there is a fire, no one is likely to ever know of the improper installation. Gaps in firestops are a definite code violation and a life safety issue (Figure 22).

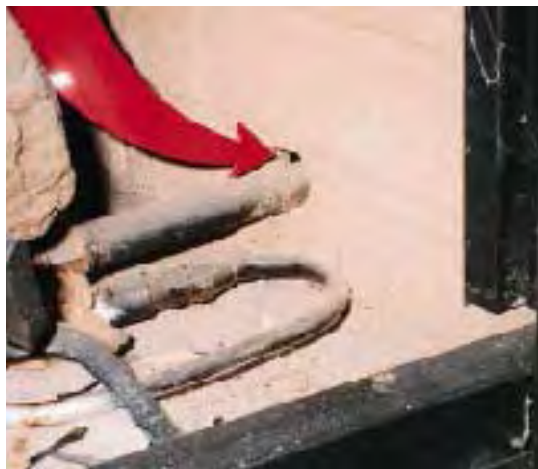
**Figure 23.** The pipe penetration into a gas fireplace must be properly sealed with a firestop material — a defect that's easy to spot and easy to fix with fireproof grout.

Mechanical fireboxes are very common in moderately priced Southern California residential construction. An unsealed gas line penetration at the mechanical firebox is one of the most common construction defects we see (Figure 23). It's a problem because fire that is supposed to be contained within the mechanical firebox could spread to the wood framing behind the box. Lucky for builders, it's also easy to recognize and easy to fix.

There's no removal of expensive finishes needed. The repair is a simple application of fireproof grout to seal around the penetration.
